St Benedicts (Tooting) Management Company Limited Flat communal areas safety work 2021-22

Page 1 of 4 Version 4.0 31 Jan 2022

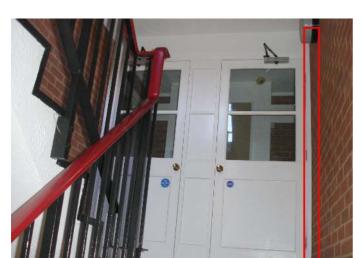
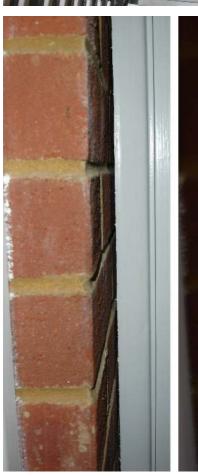
(1) Fire door frame gaps

This is required unless there is existing sound mastic fully filling the gap to the frame surface with no light visible through the gap. Gaps with existing sealant not to the surface, defective or missing sealant must be fully filled.

Agree the product to be used with the Directors then apply mastic certified to resist fire for 30 minutes to both sides of gaps between each fire door set frame (believed to number 58, each with 2 doors) and the adjoining brick walls on each side according to the manufacturer's instructions.

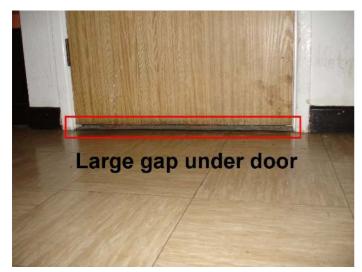
(3) Riser door gaps

Check gaps between each riser fire door and floor (number 66). For all gaps that exceed 3mm, repair as follows.

Remove any existing inadequate wooden strip or other seal at floor level.

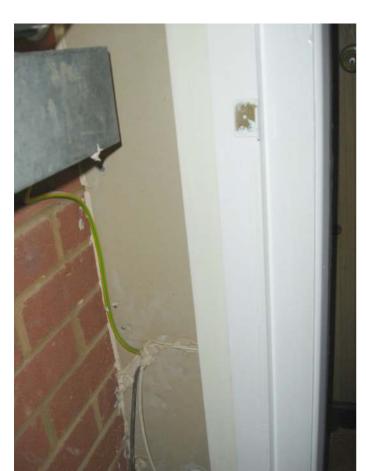
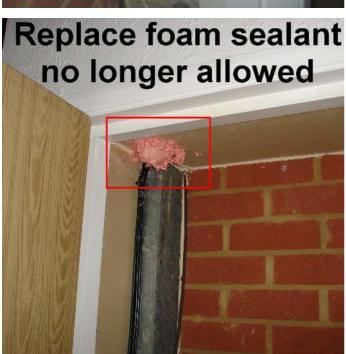
(4) Riser fire sealing

Expanding foam sealant that was previously recommended but is no longer permitted is to be raked out to a suitable depth. All gaps must be blocked.

Upgrade and where damaged repair fire sealing in each riser cupboard (number 66) to the standards now required.

Broken plasterboard must be replaced with firecertified plasterboard. Note, photograph and advise these locations so the cost of repairing damage can be re-charged to flat owners.

Any gap greater that 50mm in fire sealing must be blocked by cutting fire-certified plasterboard to shape and securely attaching it to cover the gap. Any gap less than 50mm and remaining gaps under 50mm around newly attached plasterboard must be blocked with mastic certified to resist fire for at least 30 minutes applied according to the manufacturer's instructions.
